# Shuttle Rudder/Speed Brake Power Drive Unit (PDU) Gear Scuffing Tests With Flight Gears

Margaret P. Proctor and Fred B. Oswald  
Glenn Research Center, Cleveland, Ohio

Timothy L. Krantz  
U.S. Army Research Laboratory, Glenn Research Center, Cleveland, Ohio

## **Abstract**

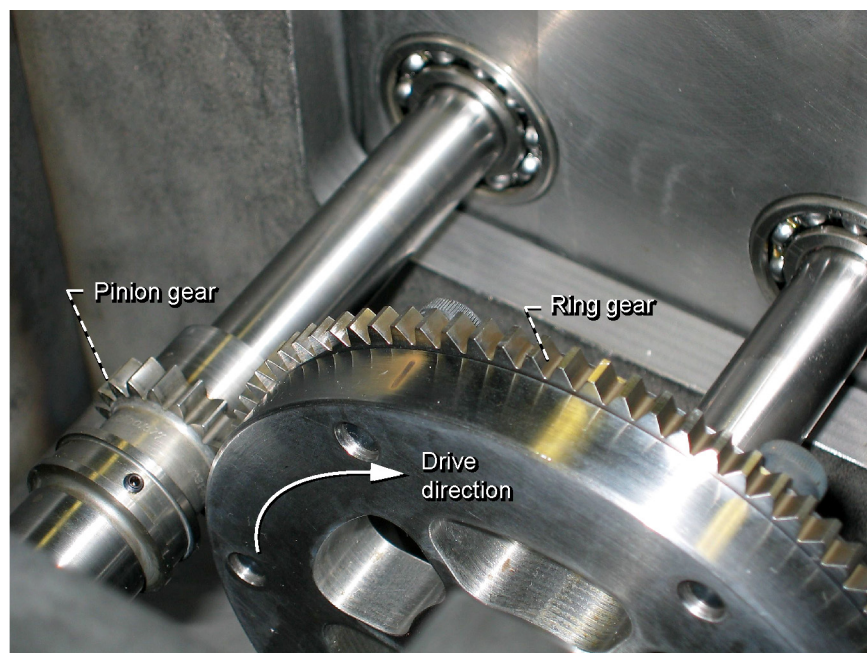
Figure 3.—Pre-test photo of ring and pinion gears installed in the test gearbox for side-1, build-1.

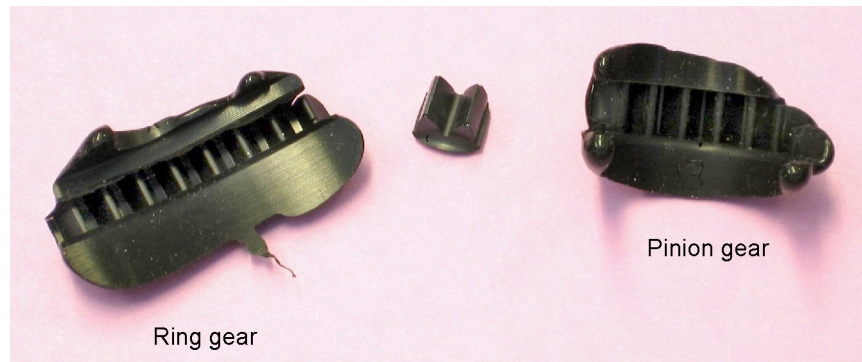
Figure 8.—Pre-test rubber mold of the pinion and ring gear teeth and the hard epoxy replication of the pinion teeth.

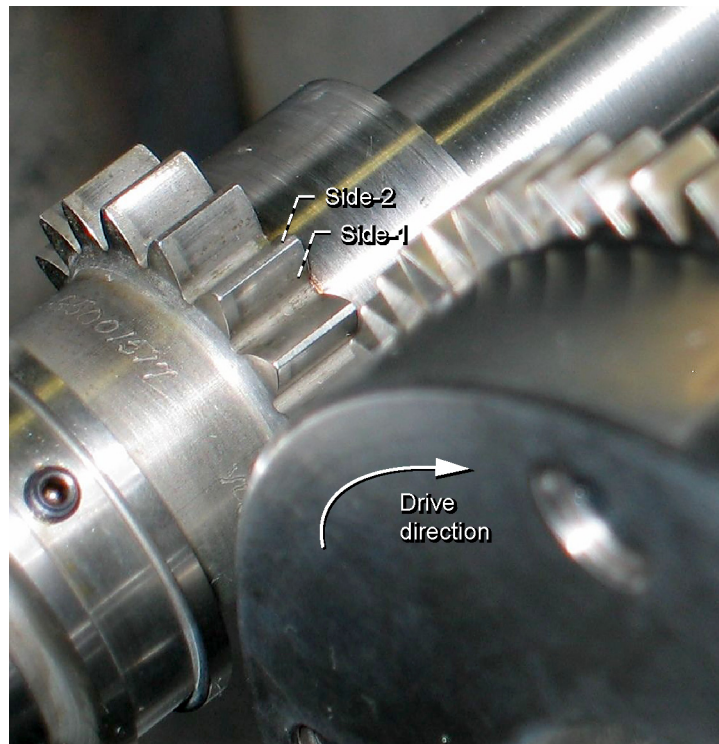
Figure 9.—Pre-test photo of pinion teeth.

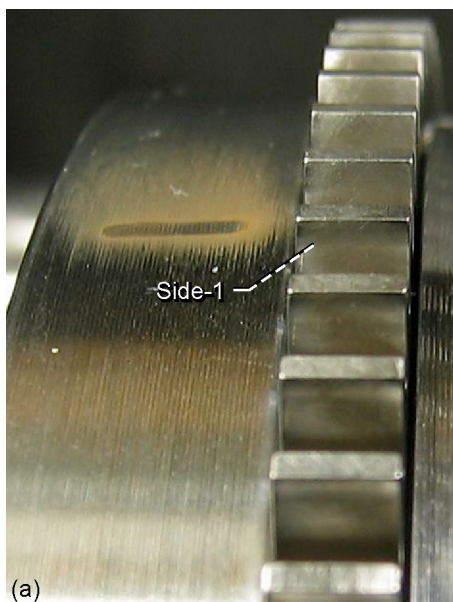
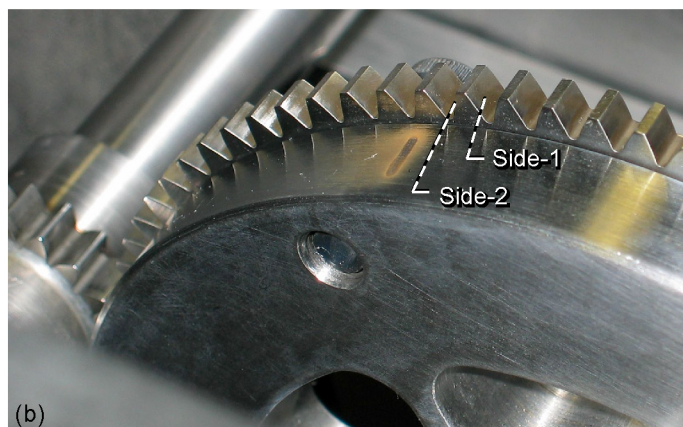
Figure 10.—(a) Pre-test photo of ring gear teeth showing side-1. (b) Pre-test photo showing another view of ring gear teeth, side-1 and side-2.

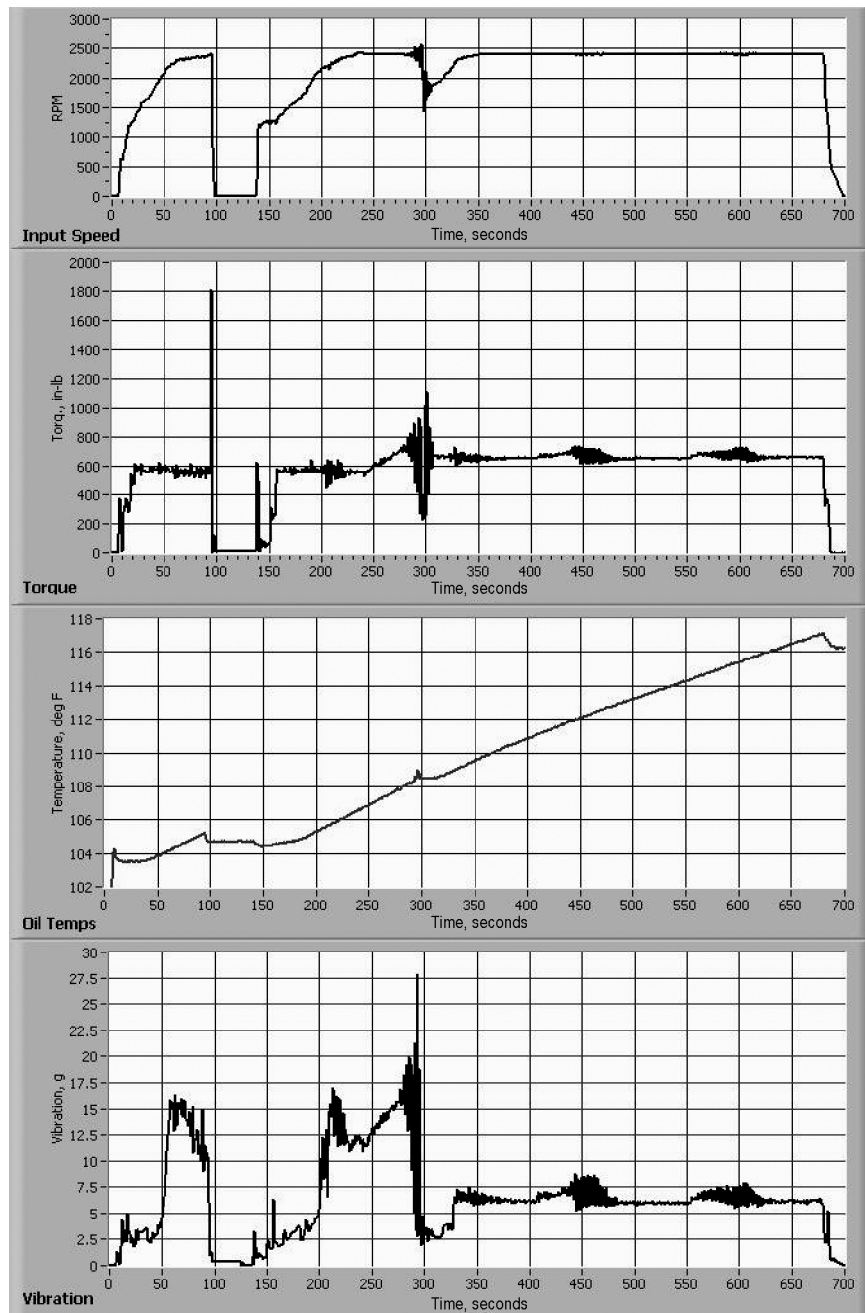
The only tests that generated any damage beyond normal polishing wear of the gear teeth were Back-3c, Score-1, and Score-2. The Back-3c test was conducted at an input speed, torque, and power of 2402 rpm, 664 in.-lb, and 25.3 hp. A plot of the time history of the speed, input torque, oil fling temperatures, and the pinion vibration levels for Back-3c is shown in figure 11.

Figure 11.—Time history of test Back-3c with side-1, build-1 showing input ring gear speed and torque, oil fling temperature and vibration data from the accelerometer near the pinion shaft.

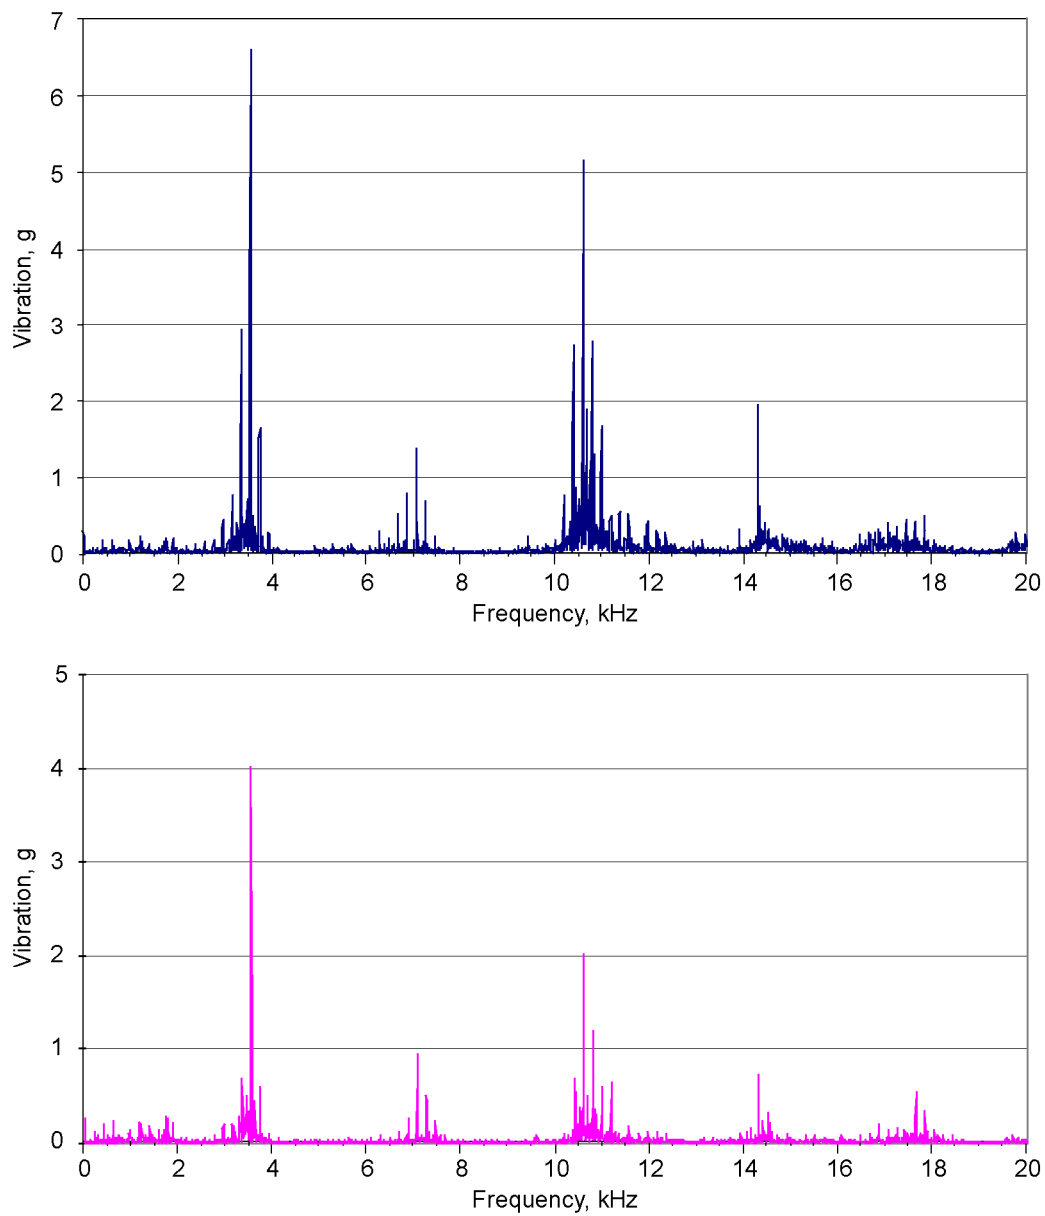
Frequency spectra of the accelerometer located near the pinion shaft taken at 250 and 550 sec are shown in figure 14 (a) and (b), respectively. The spectra show the vibration frequencies for the first four harmonics of gear mesh frequency. If we speculate that the tooth damage observed after this test occurred at 300 sec, when the oil temperature increased, we might expect to see a difference in these vibration traces because of this damage. However, the traces do not show any indirect evidence of a change to the tooth surfaces.

Figure 14.—Frequency spectra from test Back-3c at 250 sec (top) and 550 sec (bottom). The first harmonic of gear mesh frequency occurs at 3523 Hz ( $2402 \text{ rpm} \times 88 \text{ teeth}/60 \text{ sec/min}$ ).

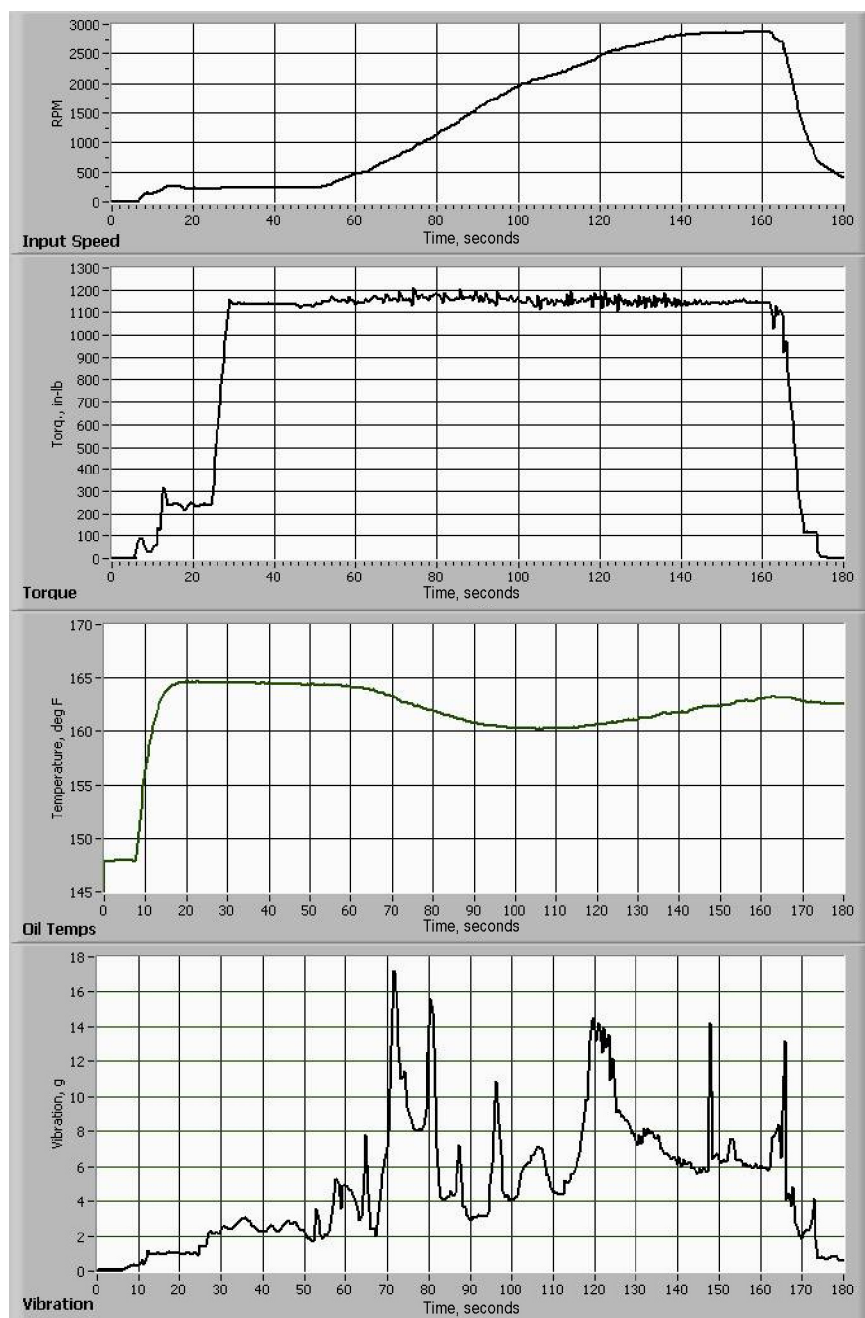
Small wear marks near the tips of the driven side of the pinion teeth (fig. 15), were generated during the Score-1 test on side-2, build-1 conducted at input speed, torque, and power of 2865 rpm, 1167 in.-lb, and 53 hp. No corresponding wear was observed on the ring gear teeth as shown in figure 16. The time histories of input speed, input torque, oil fling temperature, and pinion vibration are shown in figure 17. There is no distinct corroboration of vibration rise and fling temperature rise as in the Back-3c test. There are some high vibration levels in the test however. The drop in oil fling temperature is likely due to turning off the heat gun and heat lamp prior to rotation and some initial cooling due to flinging the oil to cooler surfaces above the oil bath.

Figure 17.—Time histories of input ring gear speed and torque, oil fling temperature and pinion rms vibration level for Score-1 test on side-2, build-1.
